Nuclad Cladding System

Impact Resistance Test Report

AS/NZS 4040.5:1996

Document No.
30B-12-0015-TRP-264917-2

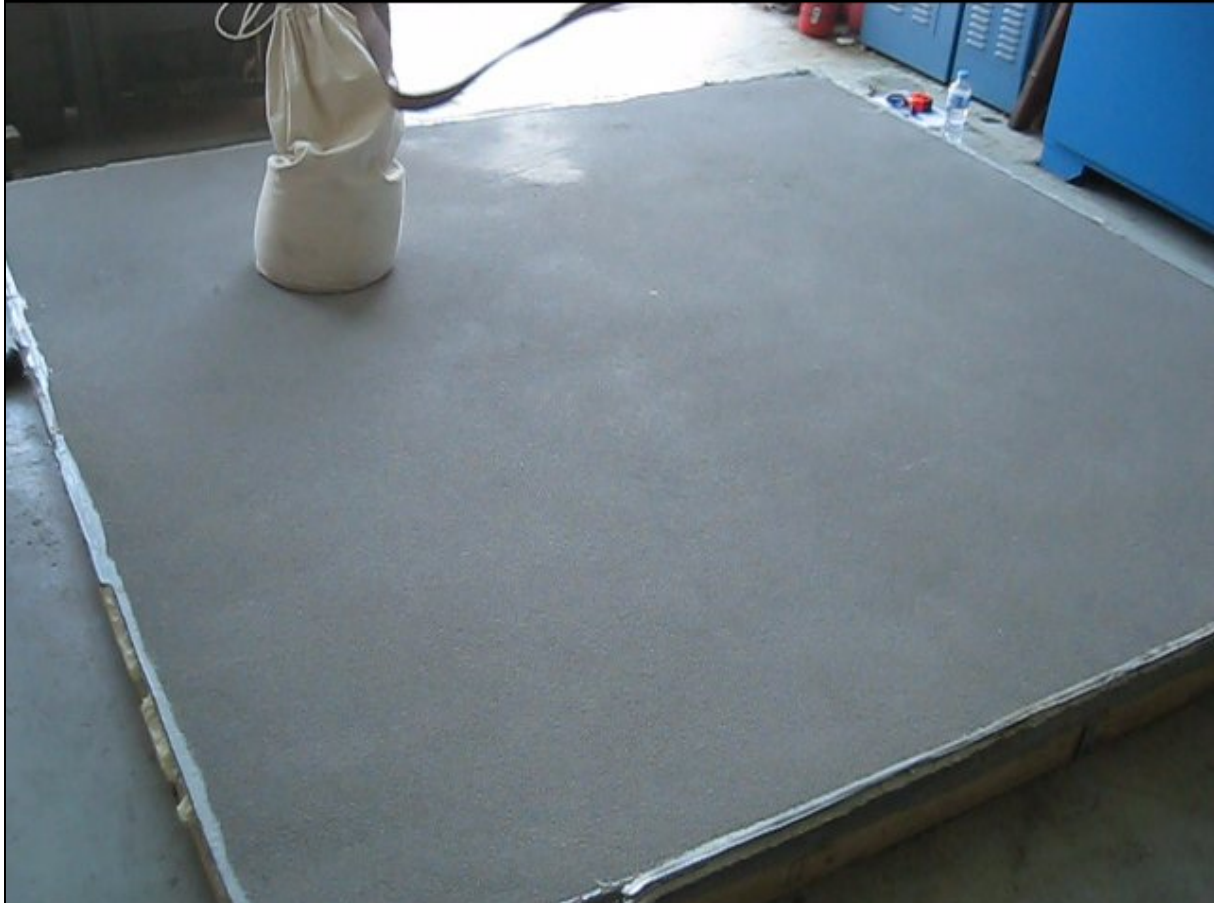
Figure 3: Sandbag impacting at Point 1

The test specimen did **not** experience any damage, deformation or dislodgement of the cladding as a result of the impact test. The impact did **not** cause the cladding to disengage.

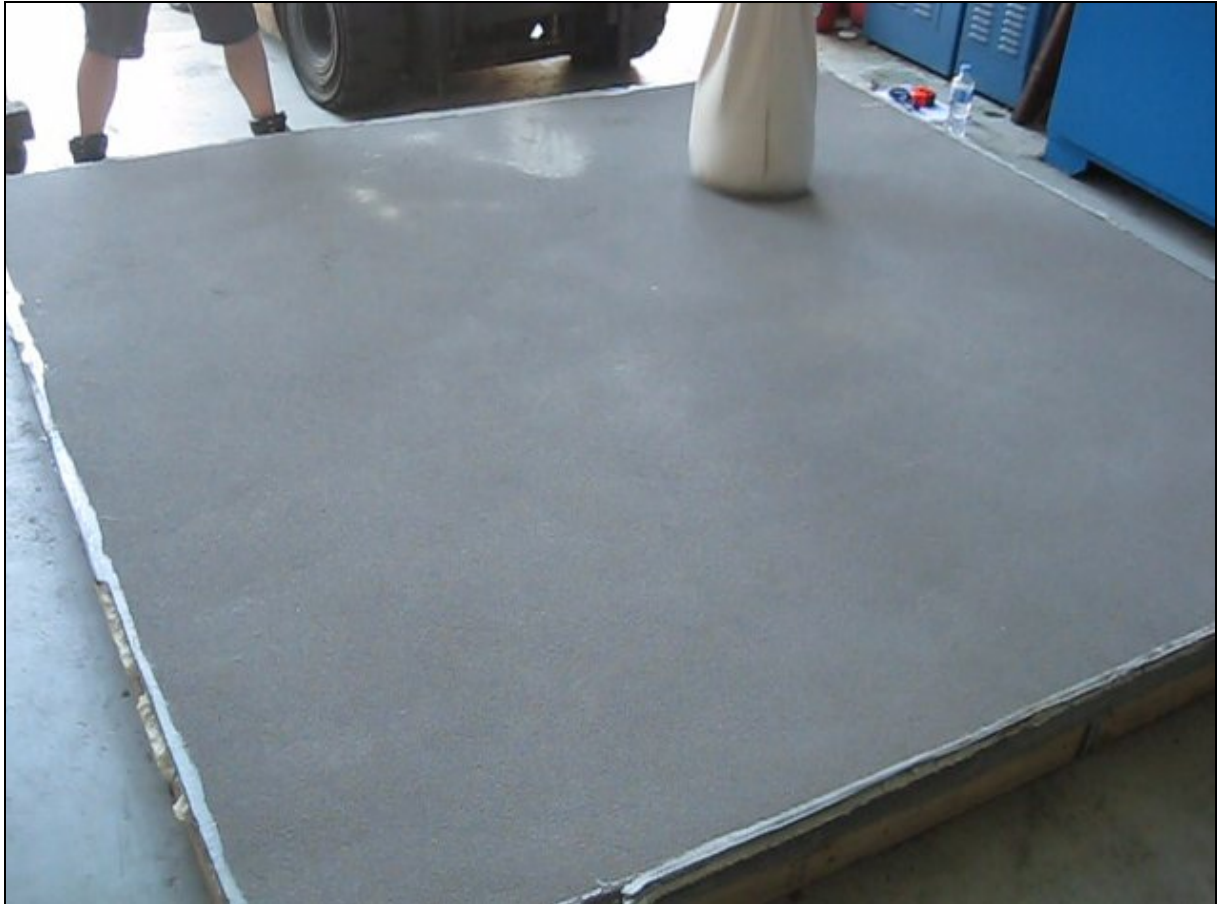
Figure 4: Sandbag impacting at Point 2
