Nuclad Cladding System

Structural Test Report

AS1562.1:1992

Document No.
30B-12-0015-TRP-264454-2

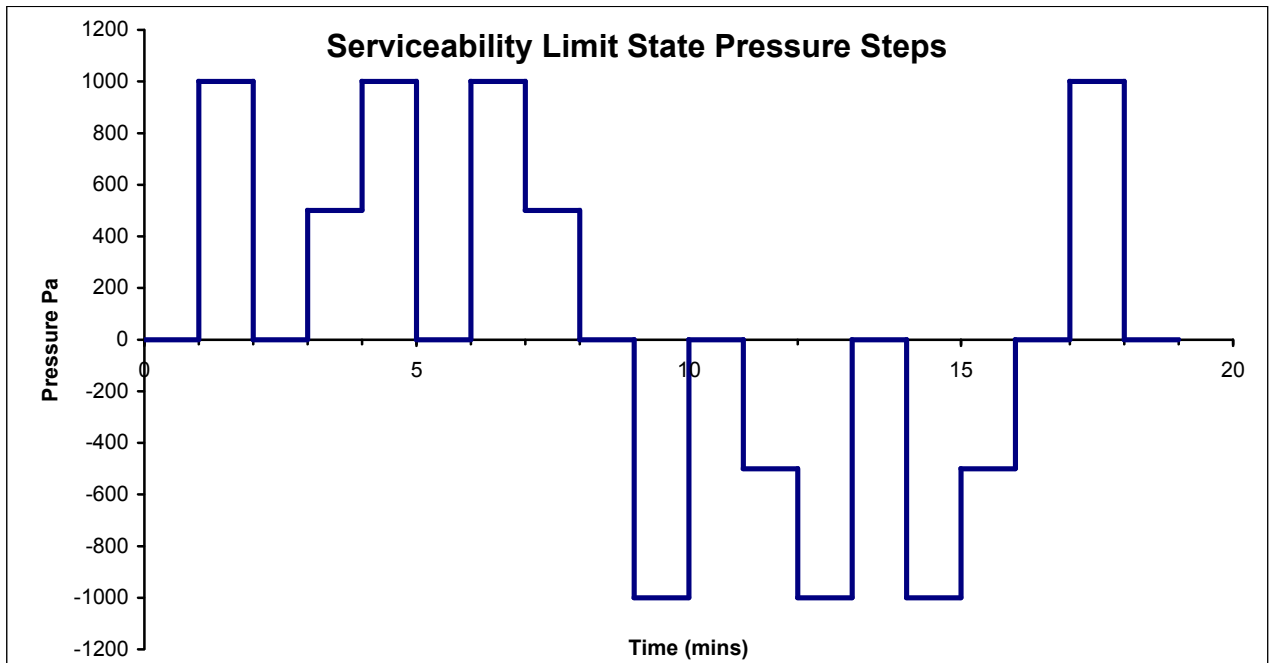
Figure 3: Serviceability Limit State Pressure Steps

Test Pressure: Region N2 Non-Cyclonic - Positive 1000 Pa & Negative 1000 Pa

Section 8.3 of AS/NZS 4284 was used as a guide for the serviceability limit state pressure steps. The steps used in this test are shown in Figure 3.

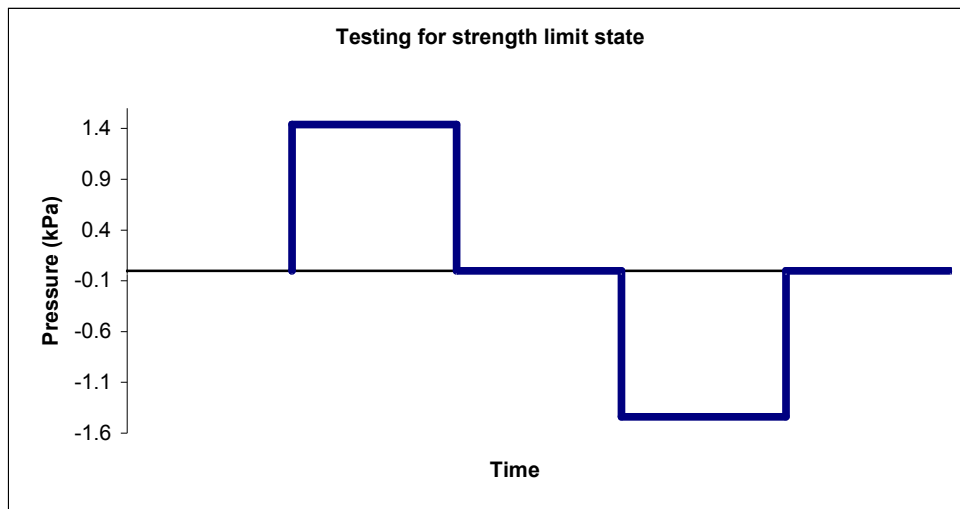
Figure 5: Strength Limit State Test Pressure Steps

- Date:** 15th February 2012
- Test Standard:** AS 1562.1:1992 and AS/NZS 4284:2008
- Test Pressure:** Region N2 non-cyclonic positive and negative 1.44 kPa for the duration of no less than 1 minute
- Criteria:** At positive and negative ultimate limit state pressures of 1.44kPa all parts of the cladding system shall remain substantially in position, despite any permanent distortion of the sheeting or fasteners.

- Summary:** The Nuclad Cladding System specimen remained intact and did not experience any abnormal defects during pressure application.
- Conclusion:** Ultimate limit state results **comply** with the requirements of AS 1562.1:1992 up to region N2 non-cyclonic.

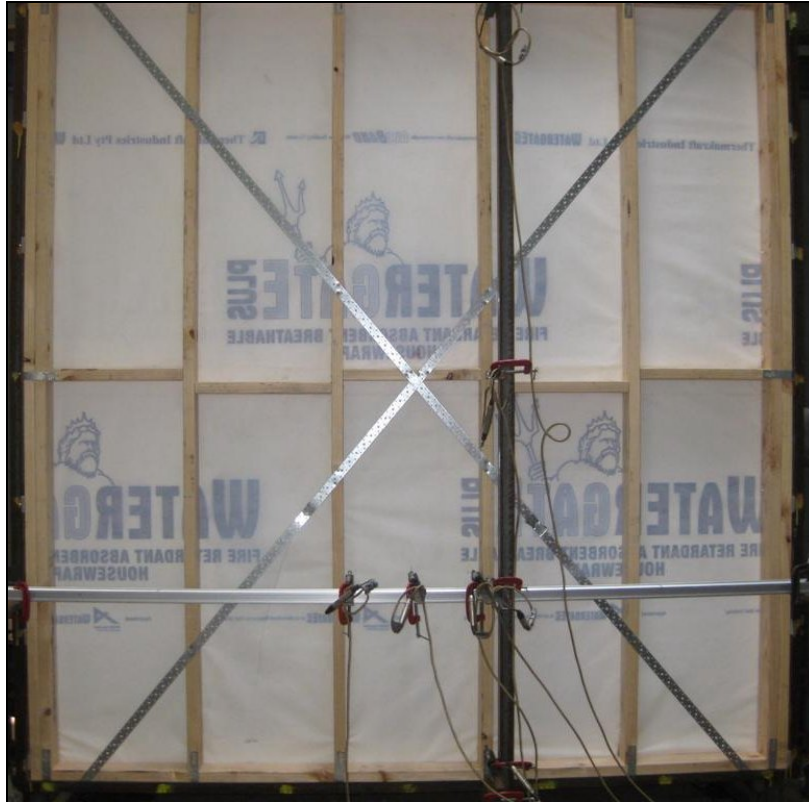
Figure 6: Serviceability deflection setup

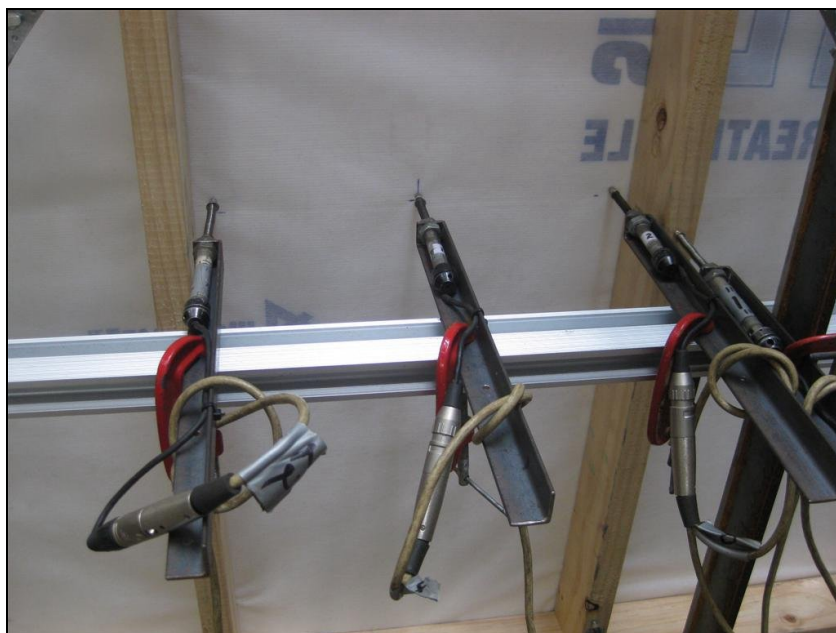
Figure 7: Cladding displacement transducer layout

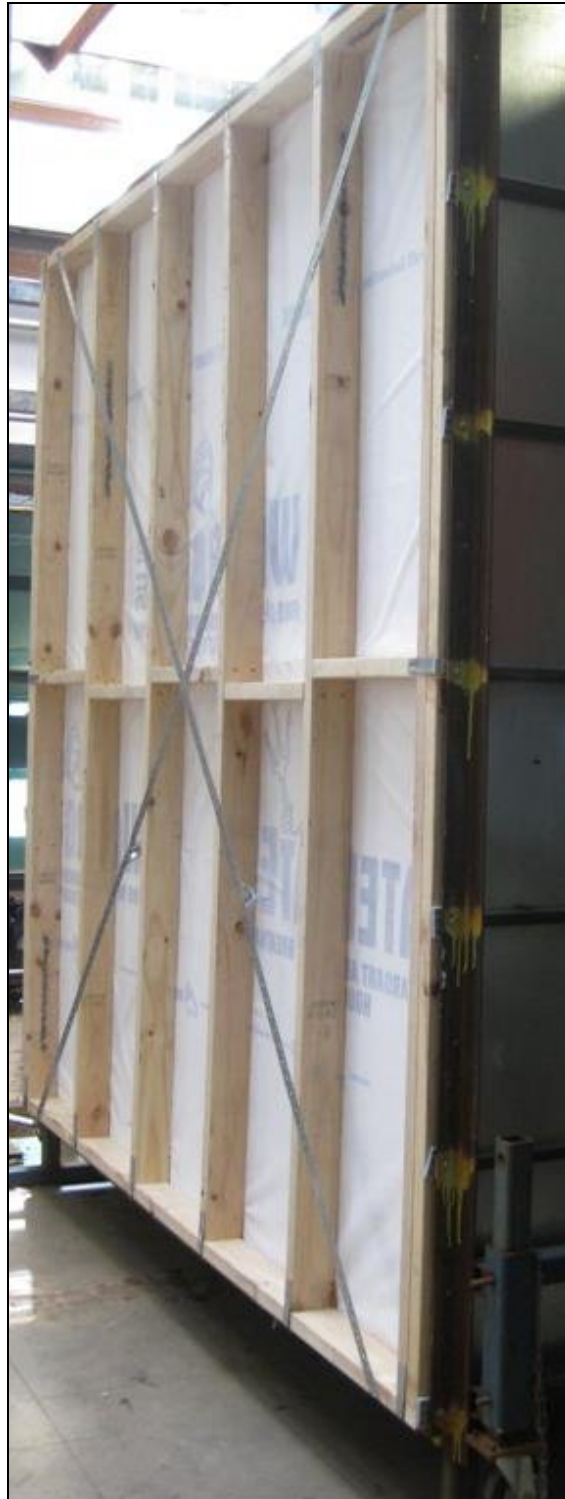
Figure 8: Test specimen under ULS negative pressure
